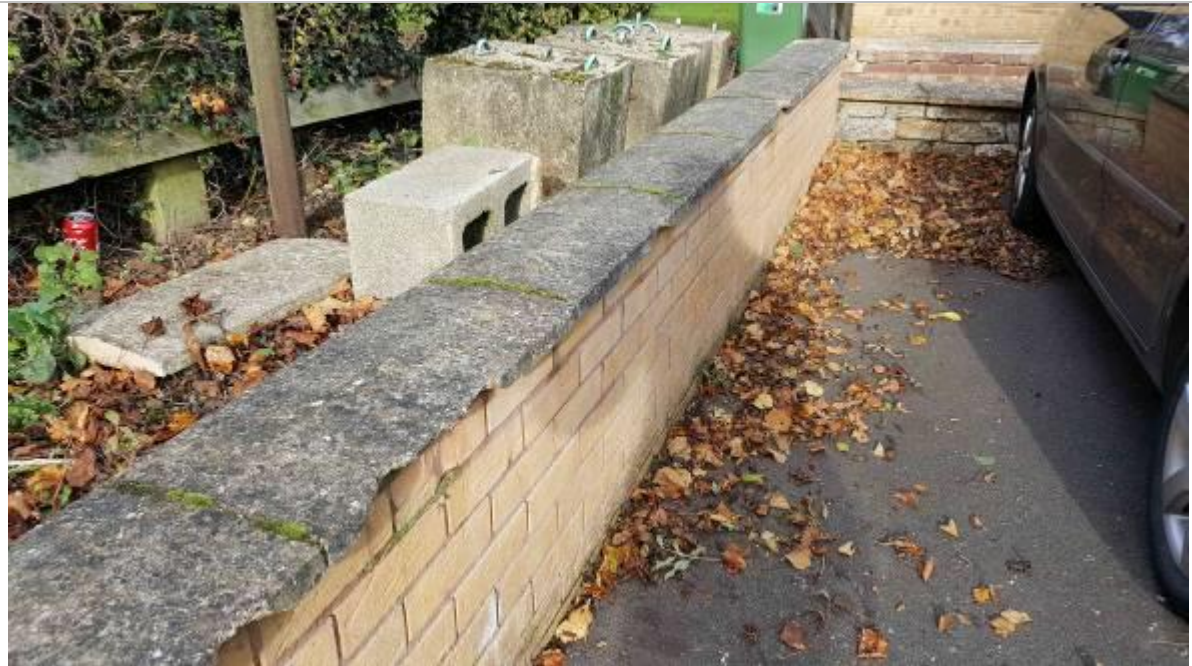
Plate 4: Coping stone damage to right hand wall of carpark.

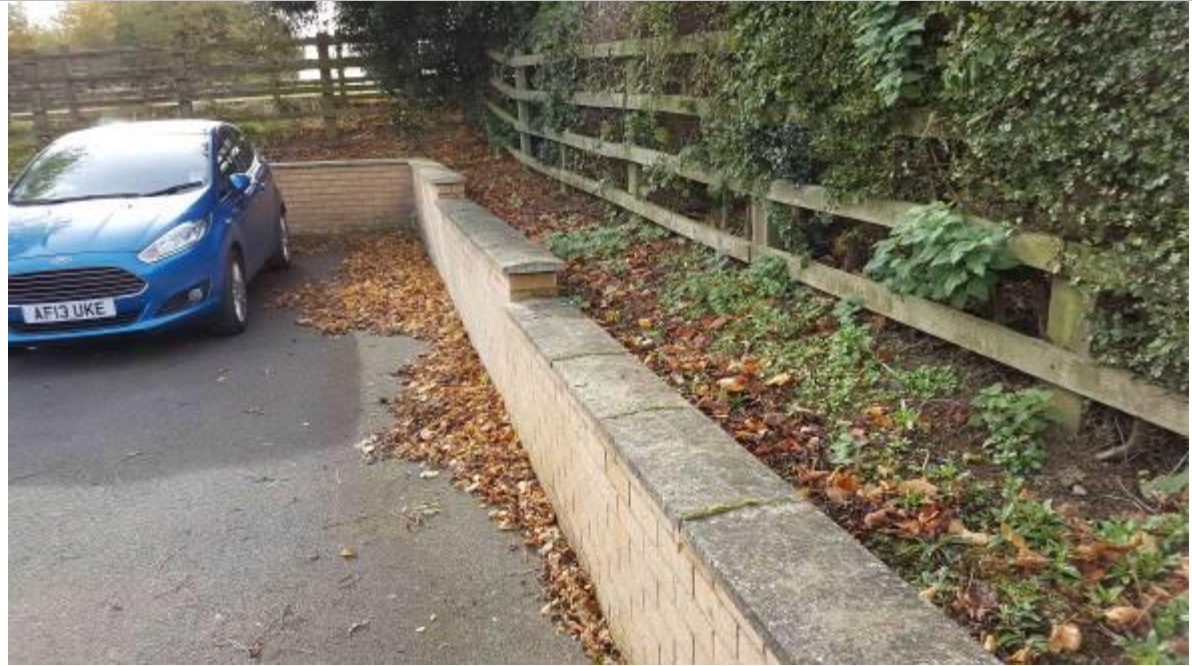
Plate 5: Heavy vegetation growth to right hand boundary.

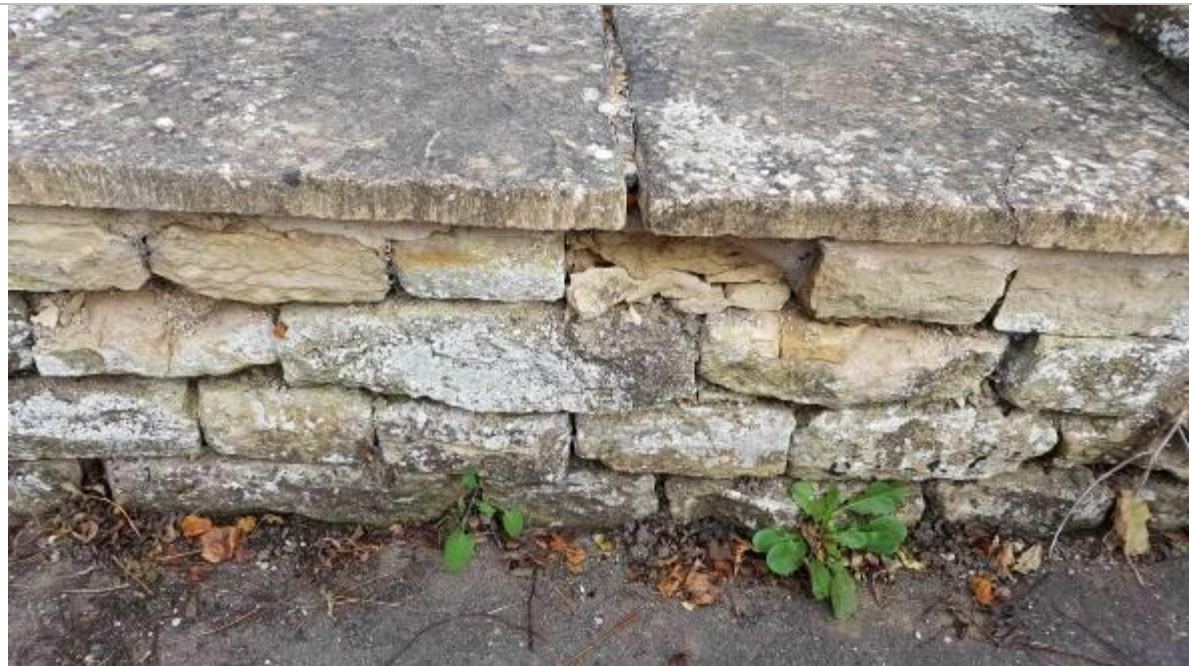
Plate 6: Dwarf stone wall to front of carpark worn.

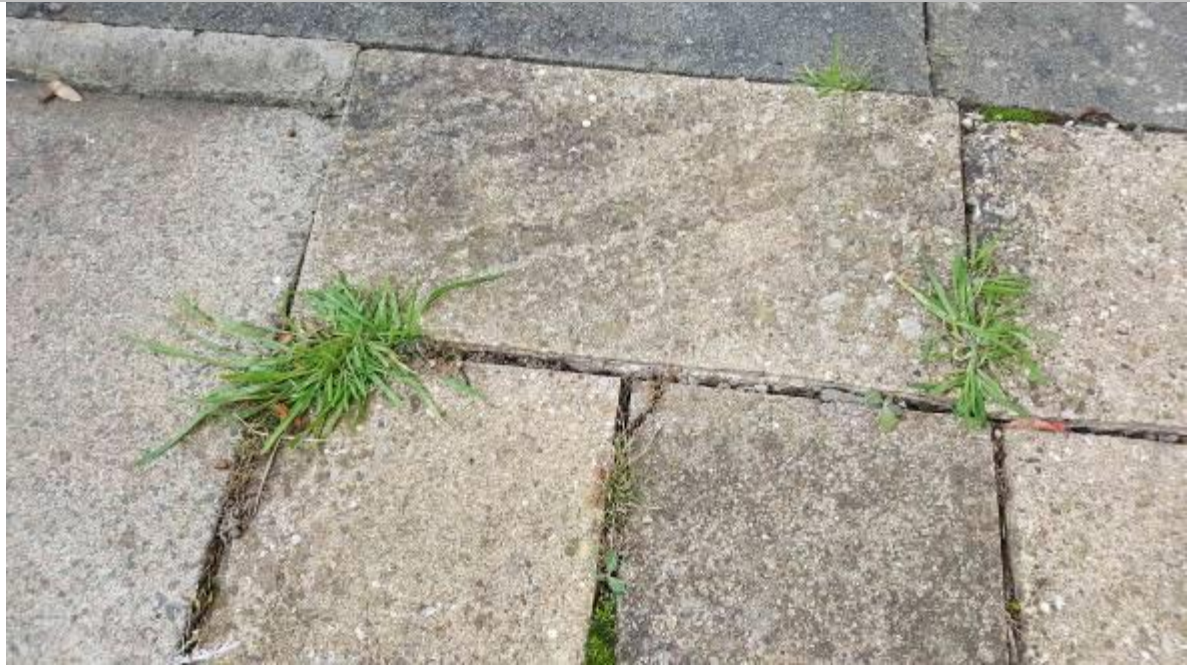
Plate 7: Uneven paving slabs to rear left corner of building.

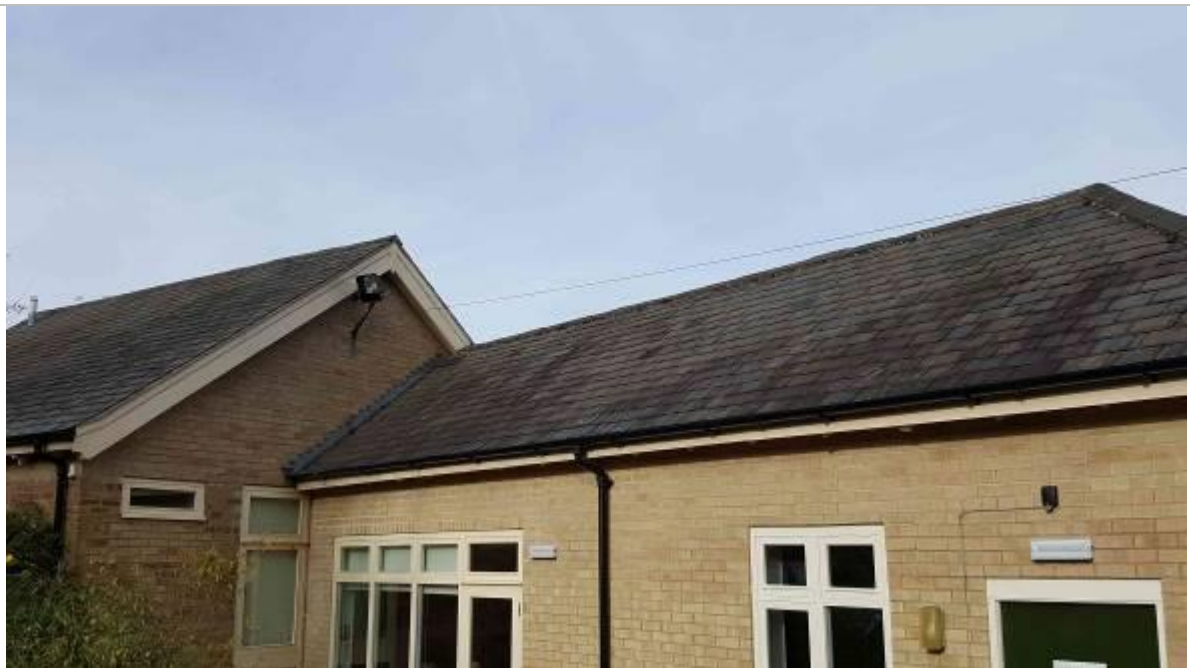
Plate 8: Rear elevation, roof in good order.

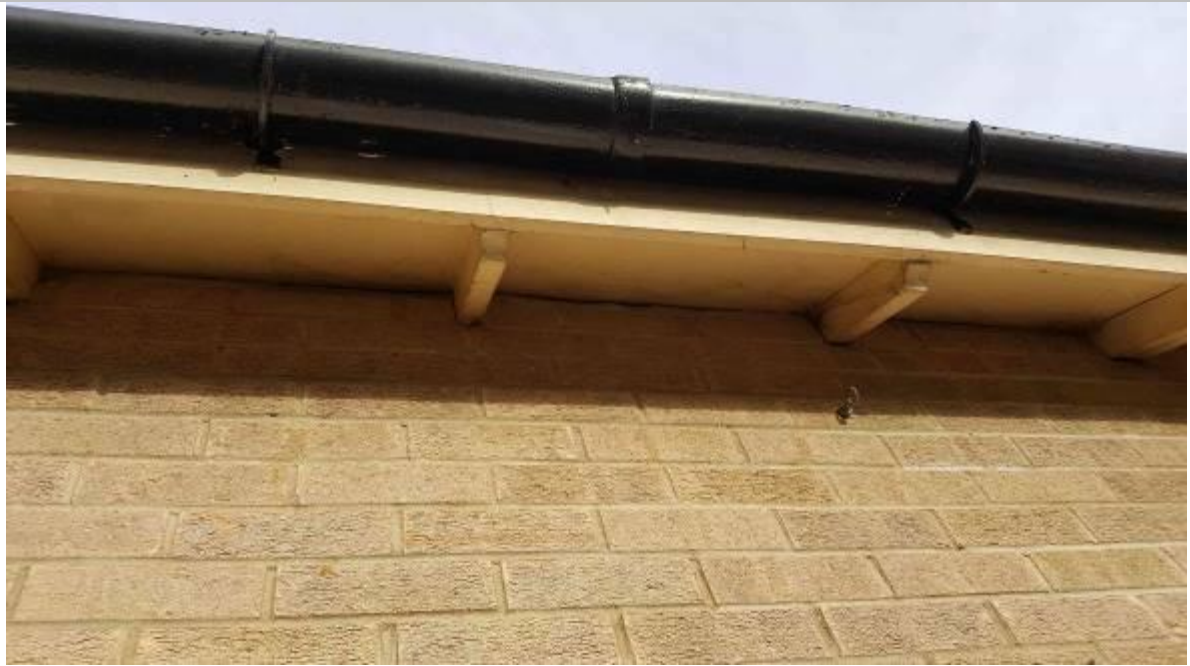
Plate 9: Slight wear to timber eaves to rear.

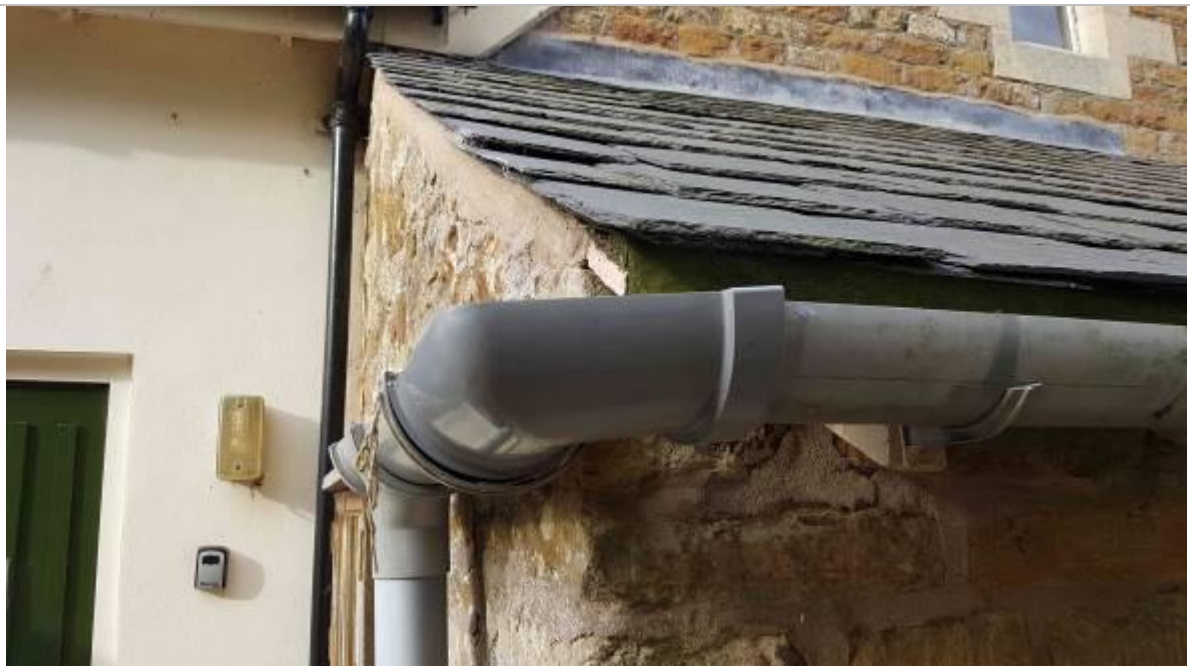
Plate 10: Inadequately supported uPVC gutter to porch to left hand side.

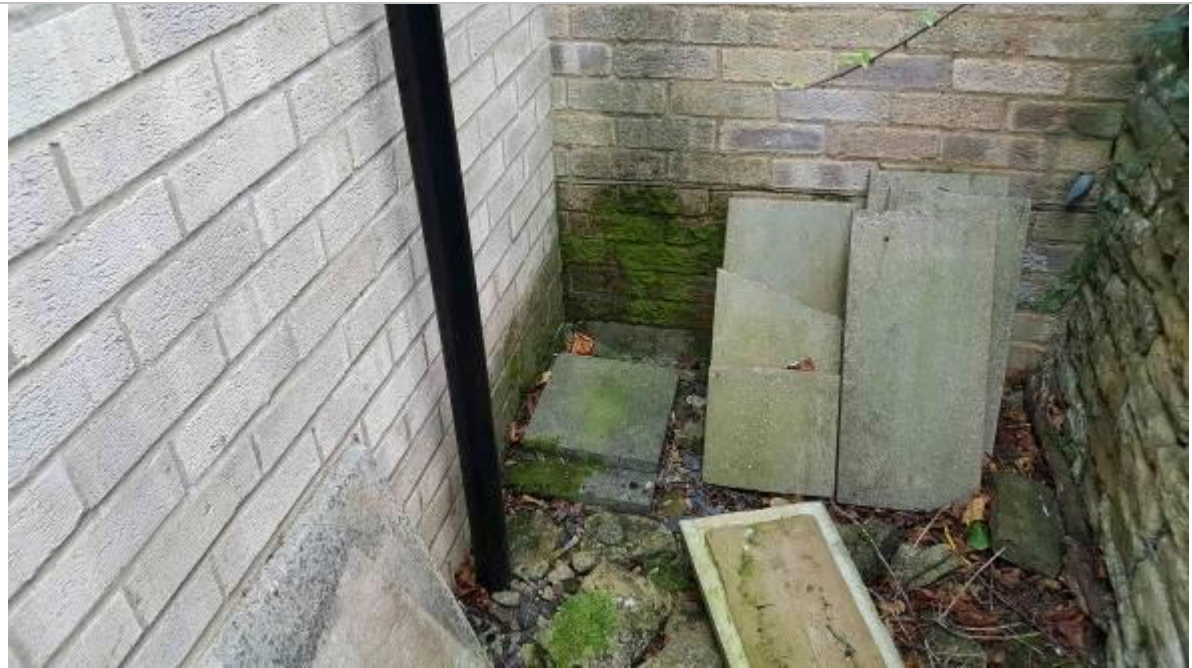
Plate 11: Moss and water staining to RHS of building.

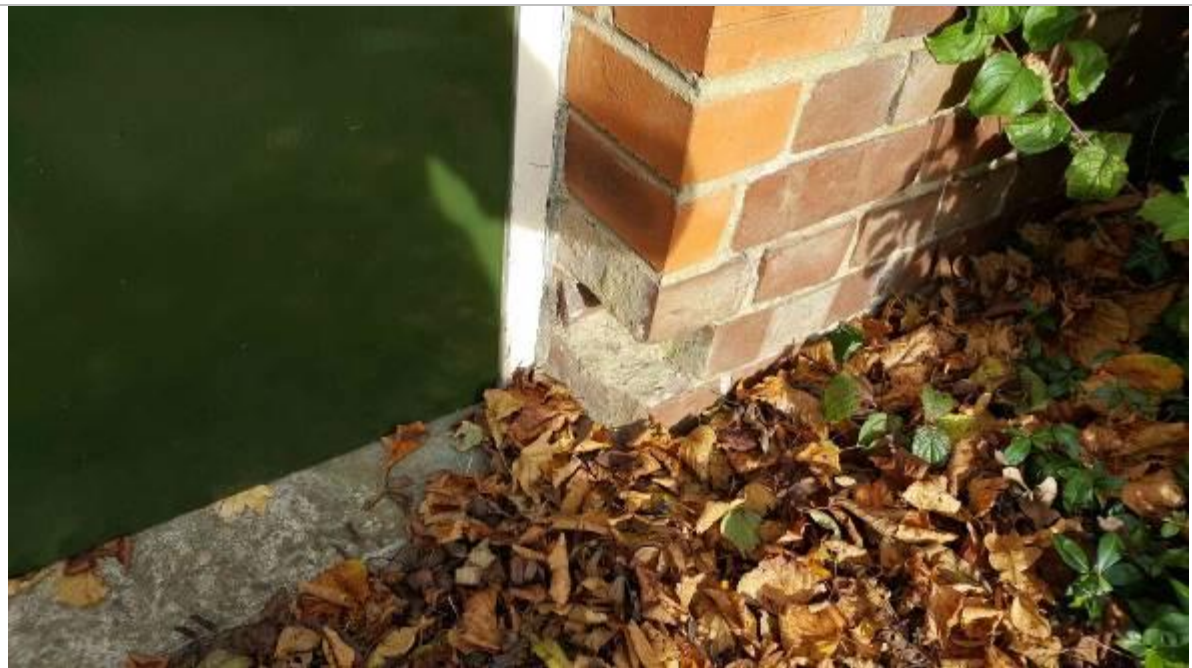
Plate 12: Wear to brickwork at low level to bottom left corner of fire door to rear.

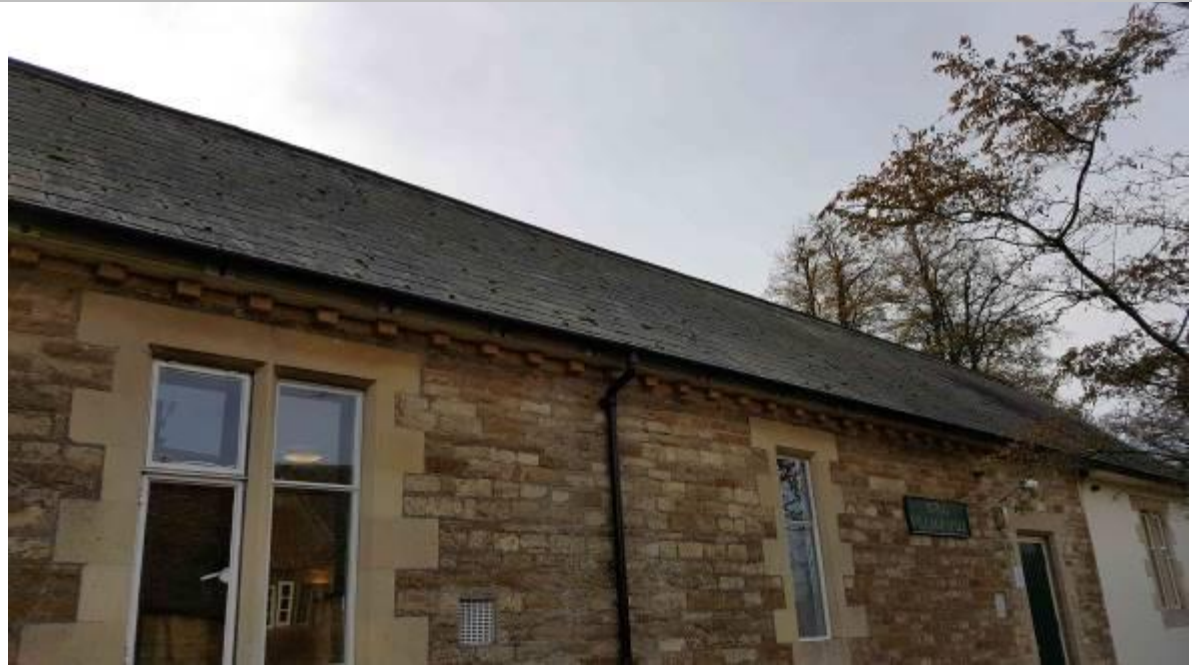
Plate 13: Moss build up to roof at the front.

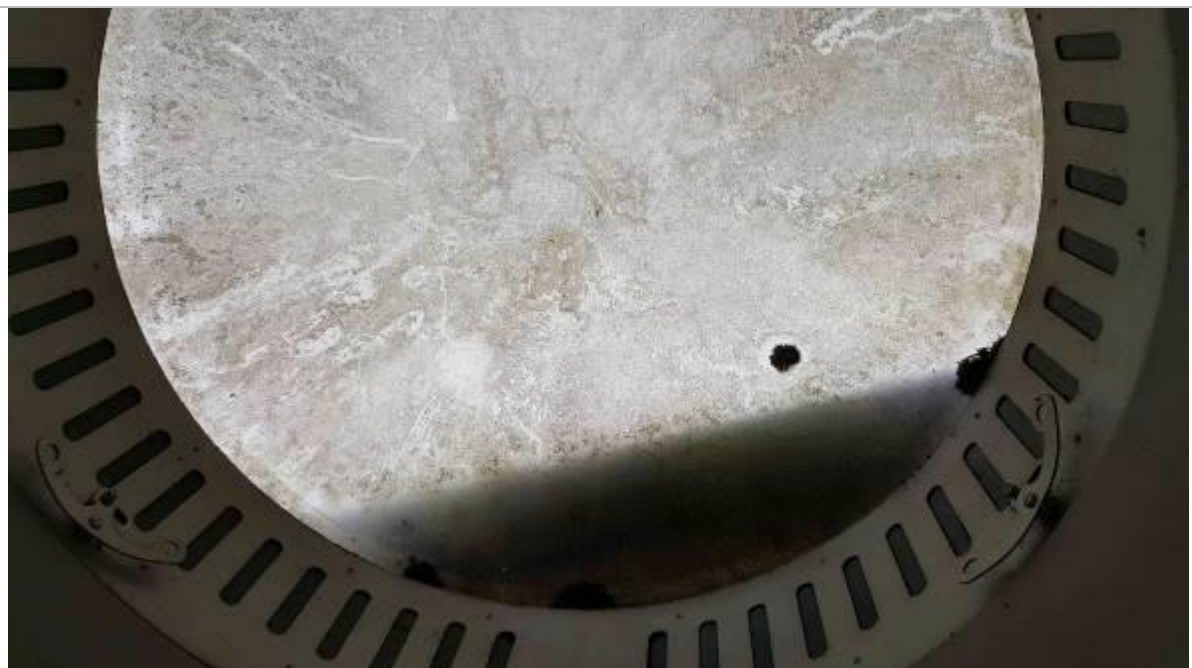
Plate 14: Skylight partly covered with grime.
